BRIDGE APPROACH/ANCHOR SLAB JOINT EVALUATION

REPORT NUMBER: FHWA-AZ97-450

BRIDGE APPROACH / ANCHOR SLAB JOINT EVALUATION

Prepared by:
Shan Sundaram
Michael Dadik
Sundaram Engineering, Inc.
833 West Portobello Avenue
Mesa, AZ 85210

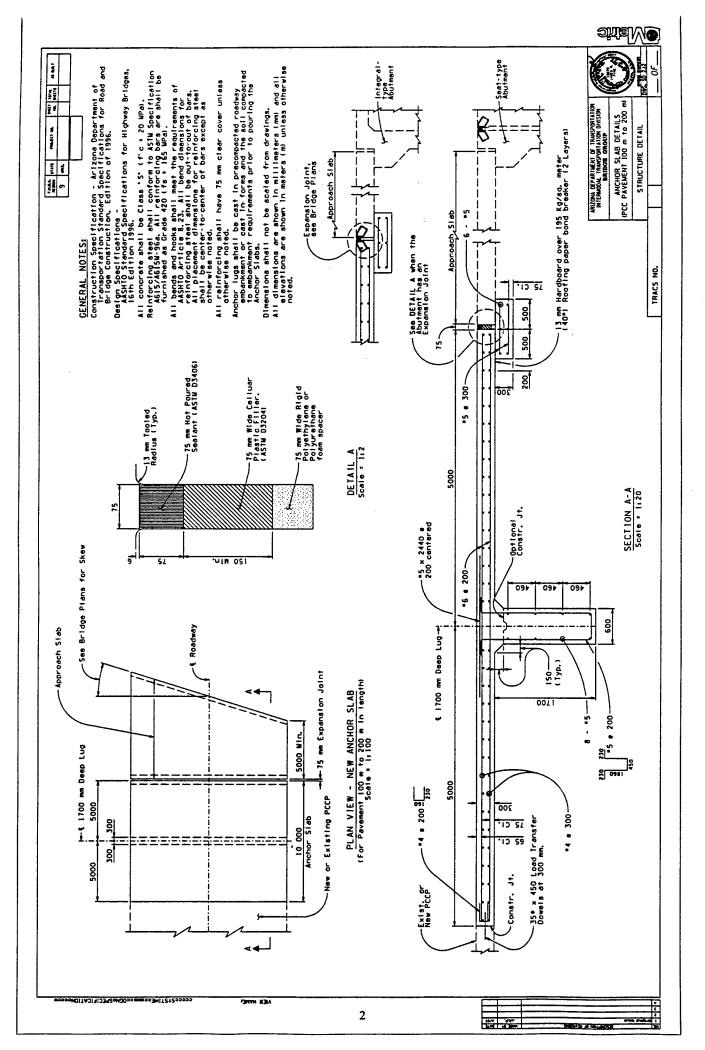
Figure 1. Current ADOT Joint

The metric equivalent of the joint as used now is shown in Figure 1. In recent years, ADOT construction and maintenance staff have been observing the deficiencies in the function of the joint. The hot poured sealant at the top layer is peeling off the edges of the slabs; water and debris find their way through the gaps between the sealant and the slabs and also through the side joints between the slab and the barriers. The material of the sealant is becoming dry and brittle and the approach slab experiences settlement adjacent to the joint. Spalling has occurred along the joint at random due to the impact of the traffic. These concerns have prompted ADOT to have a consultant investigate and evaluate the joint and make recommendations to improve and /or modify the joint to make it more functional, efficient and durable. Sundaram Engineering, Inc. is pleased to have been hired by ADOT and to have the opportunity to undertake this task and report on the findings with solutions for ADOT's verification.

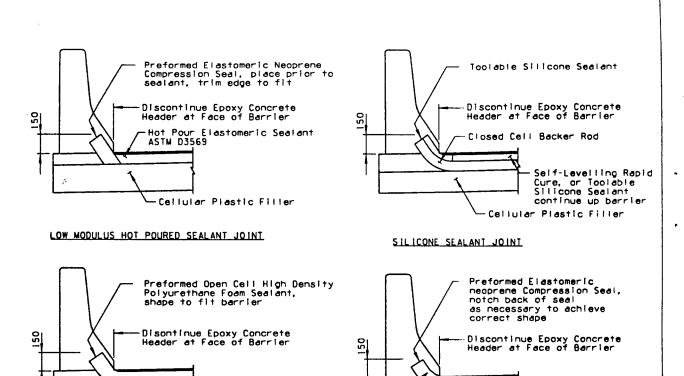
Figure 9. Terminal Treatment of Joints

-Preformed Elastomeric Neoprene Compression Seal, continue up barrier

Cellular Plastic Filler

Preformed Open Cell High Density Polyurethane Foam Sealant, continue up barrier

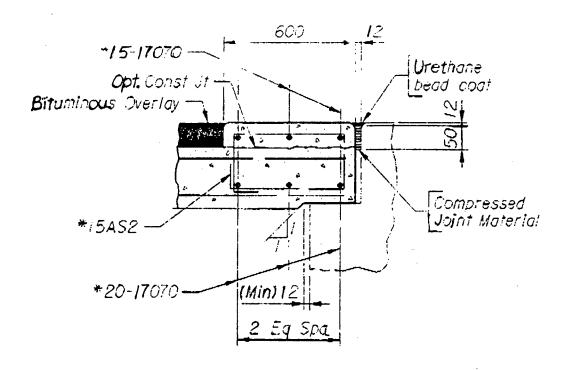
SECTION THRU JOINT BETWEEN

ABUTMENT AND APPROACH SLAB
(Dimensions measured normal to Abutment)

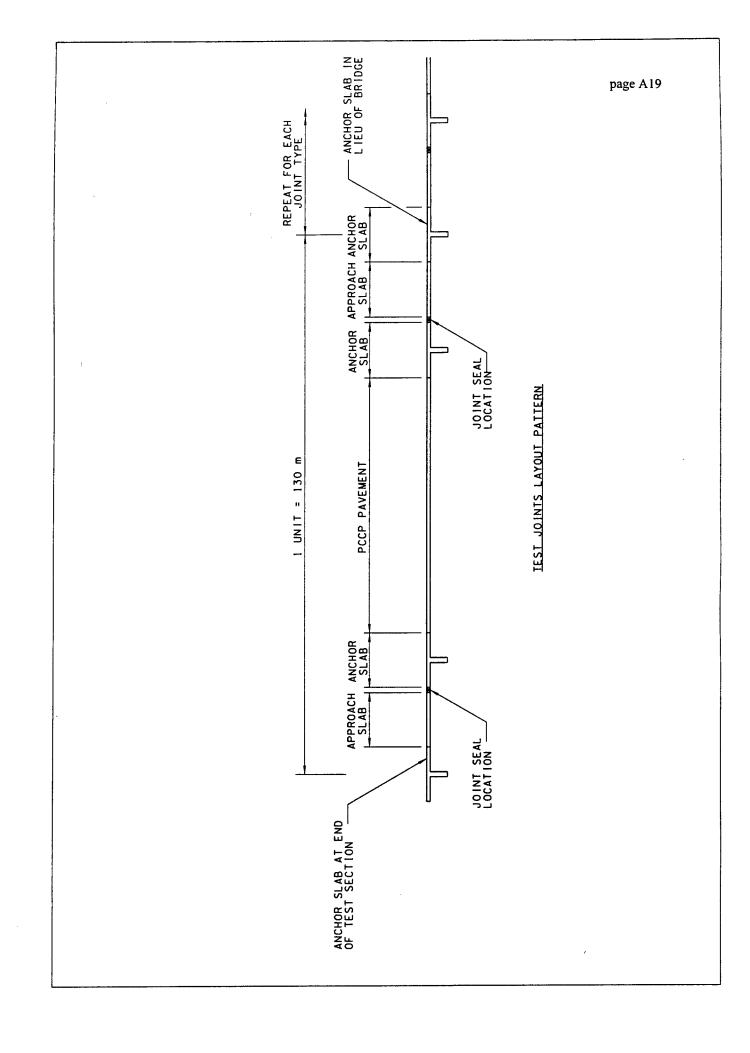
APPROACH/ANCHOR SLAB JOINT EVALUATION FORM

STRUCTURE NUMBER STRUCTURE NAME APPROACH/DEPART OBSERVER WEATHER TRAFFIC CONTROL	ROUTE DIRECTION TEMP	MILEPOST DATE TIME
GENERAL PAVEMENT CONDITION		
SEALANT TYPE FLEXIBILITY (GOOD, MEDIUM, BAD) MISSING SEALANT ADHESIVE FAILURE PARTIAL DEPTH FULL DEPTH FULL DEPTH FULL DEPTH INTRUSION OF INCOMPRESSIBLES JOINT WIDTH SEALANT RECESS SPALLING COMMENTS, SKETCH

The Joints shall be monitored at maximum 6 month intervals. The field evaluation form attached herewith (page A20) and the inspection requirements stated below shall be followed.

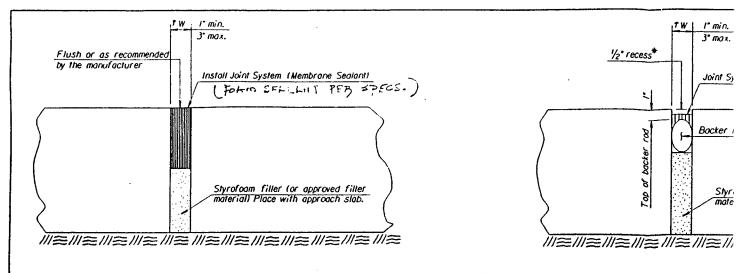
Joint System (Preformed Elastomeric Neoprene)

Styrofoam filler (or approved filler material) Place with approach slab.
